REVISED ARBORIST REPORT For 12631 Bell Street Mission, BC

Florwest Developments

February 14, 2023

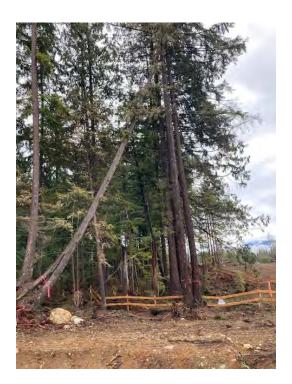
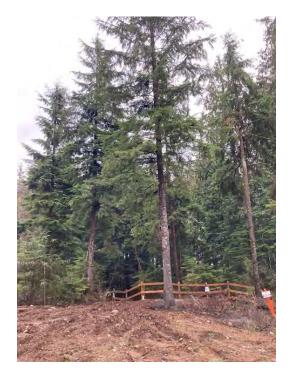
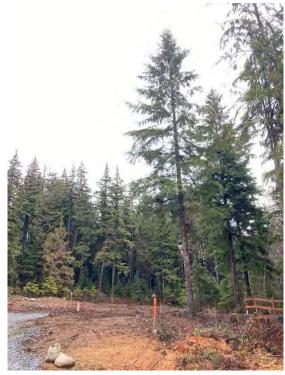
Pictures 1-3: Lot 3/Lot 4 high risk trees; clearing outside of SPEA

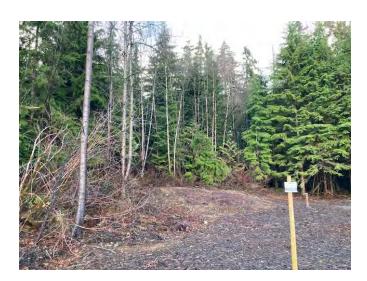
Pictures 4-7: examples of low-density areas (few protected-size trees)

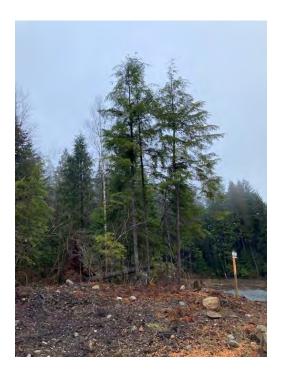
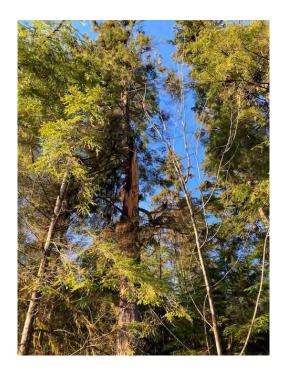
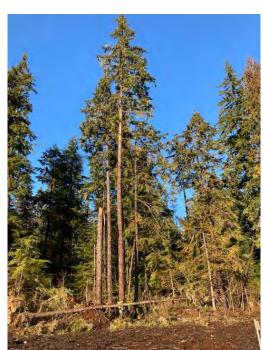
There is evidence of a wind throw concern along the north edge of the cut areas. We noted seven hemlock trees that had all blown over in the same direction, pointing to the north/northeast. This appeared rather recent, as we saw broken roots that had not yet oxidized. This has happened probably within the last few months to a year ago.

Pictures 8-11: examples of wind damage, north edge

We conclude that wind throw is not a huge concern for the proposed new development, but we do caution that all trees should be assessed on a regular basis.

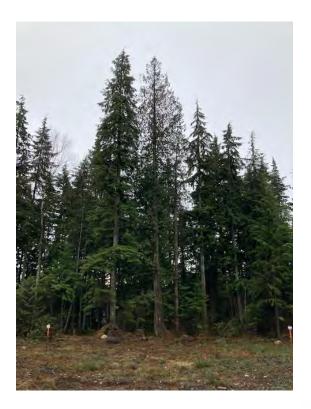
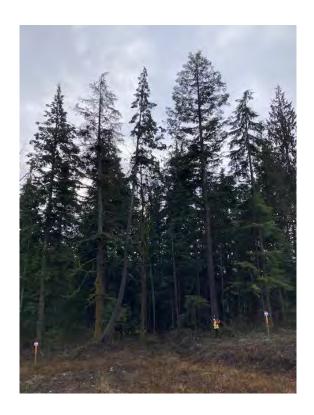
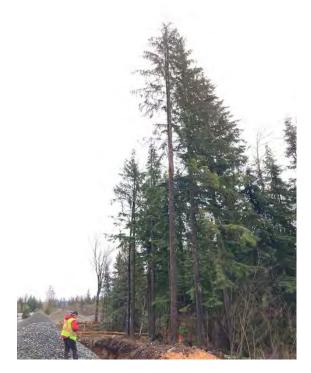
Pictures 12-14: trees in decline, south edge
