CITY OF MISSION DEVELOPMENT PERMIT DP23-035

Development Permit DP23-035

Riparian Areas Protection Regulation - Qualified Environmental Professional - Assessment Report

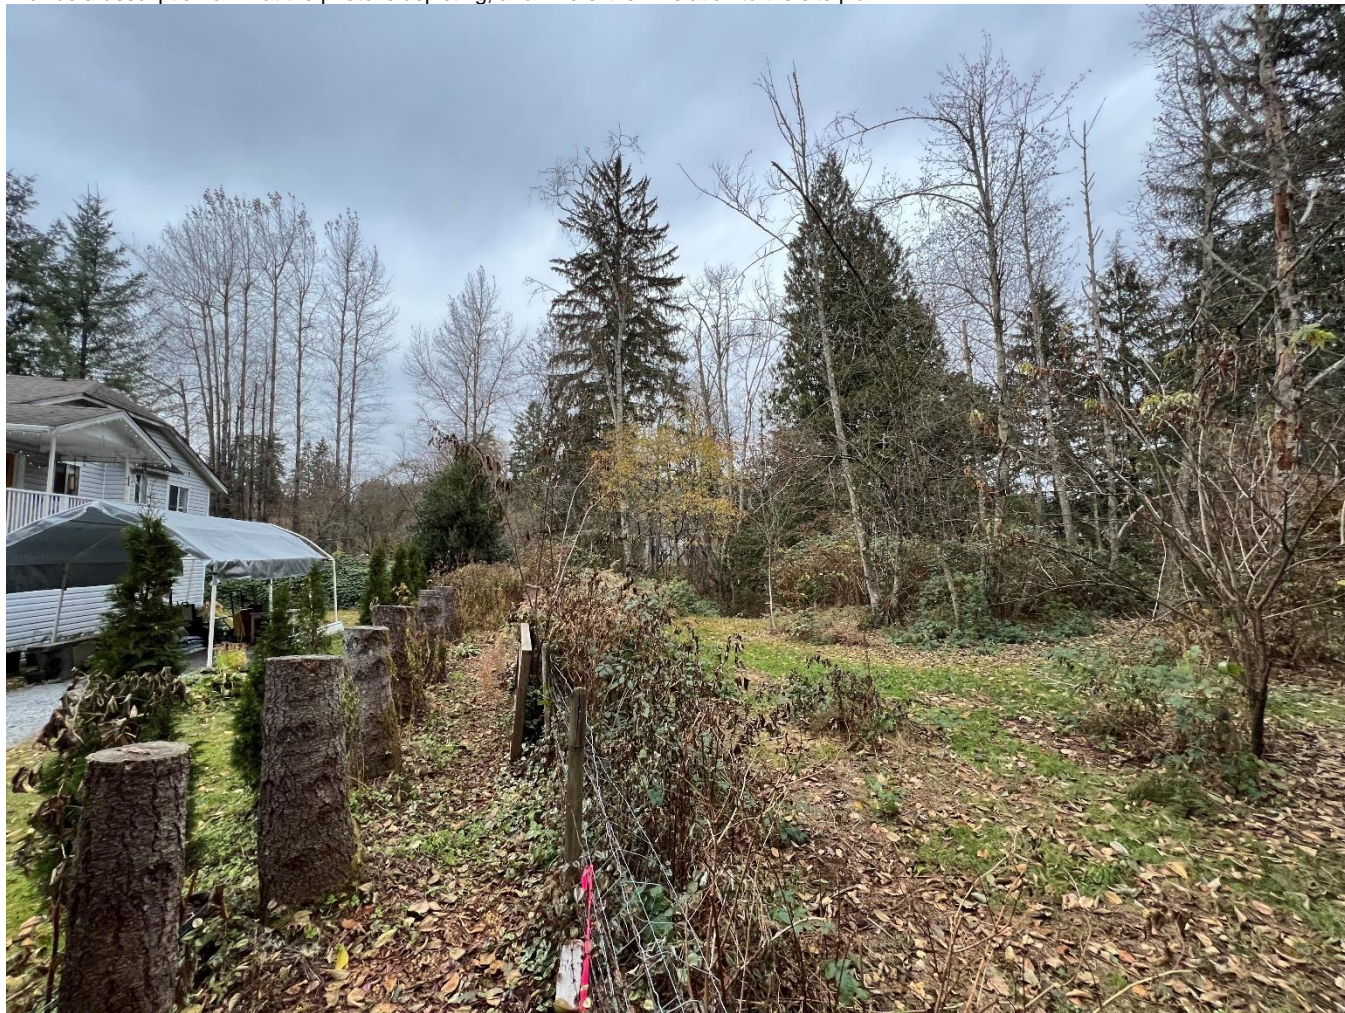
Photograph 1. View of the northeast corner of the subject property (existing house, carport, cedar hedges and row of cut stumps) and adjacent property to the east consisting of semi-maintained riparian vegetation around the watercourse.

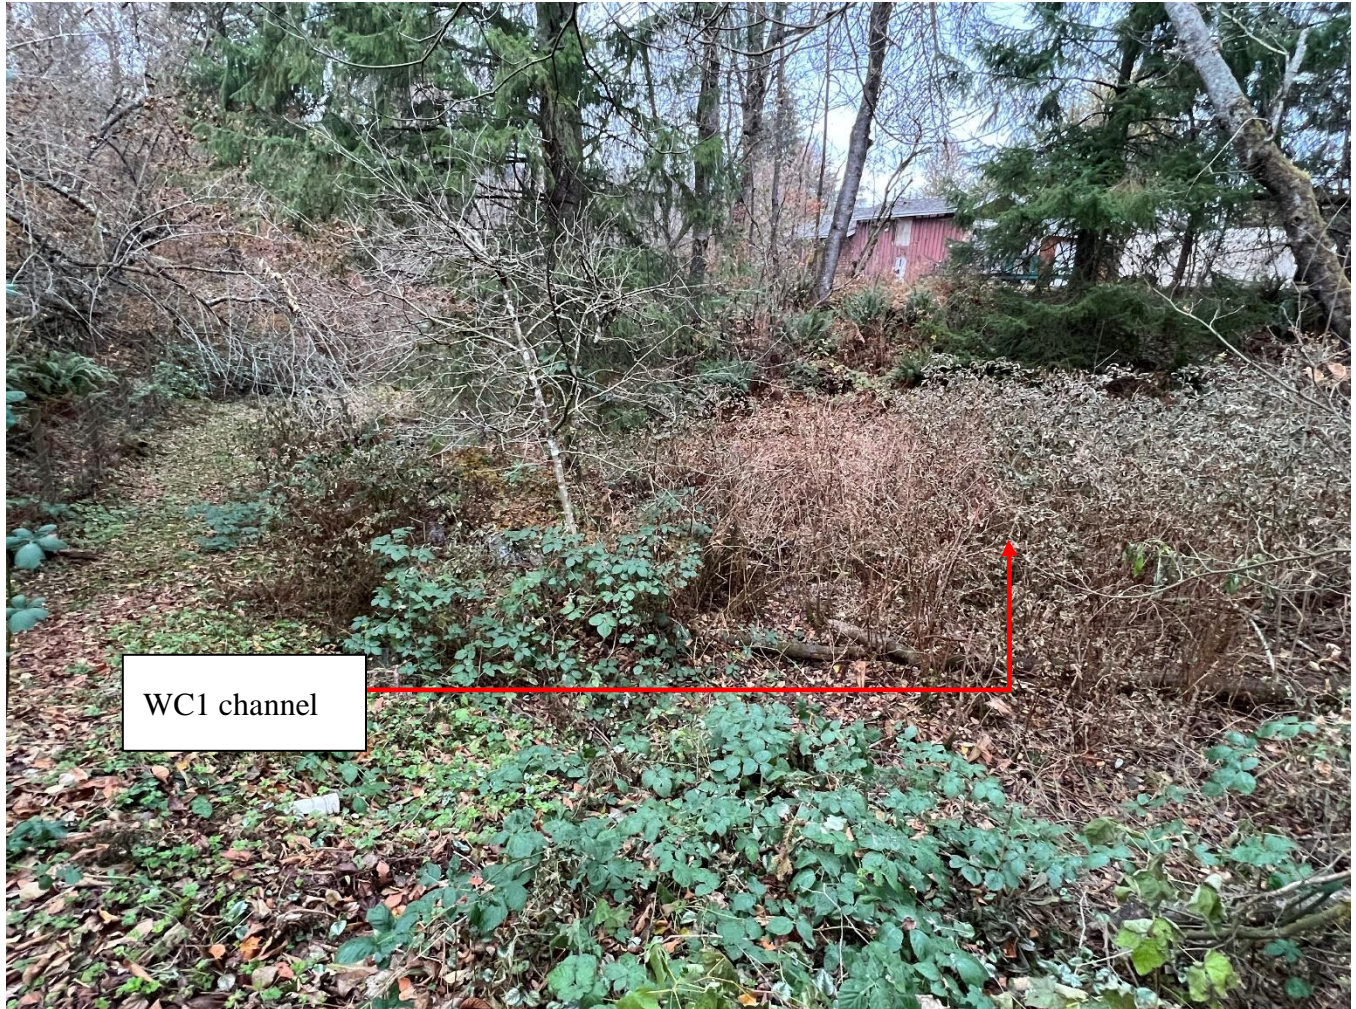
Photograph 2. View of the mixed native and invasive riparian vegetation on the adjacent property (facing north) located approximate 10 m from the subject property. A drain pipe from the subject property was observed close to this location.

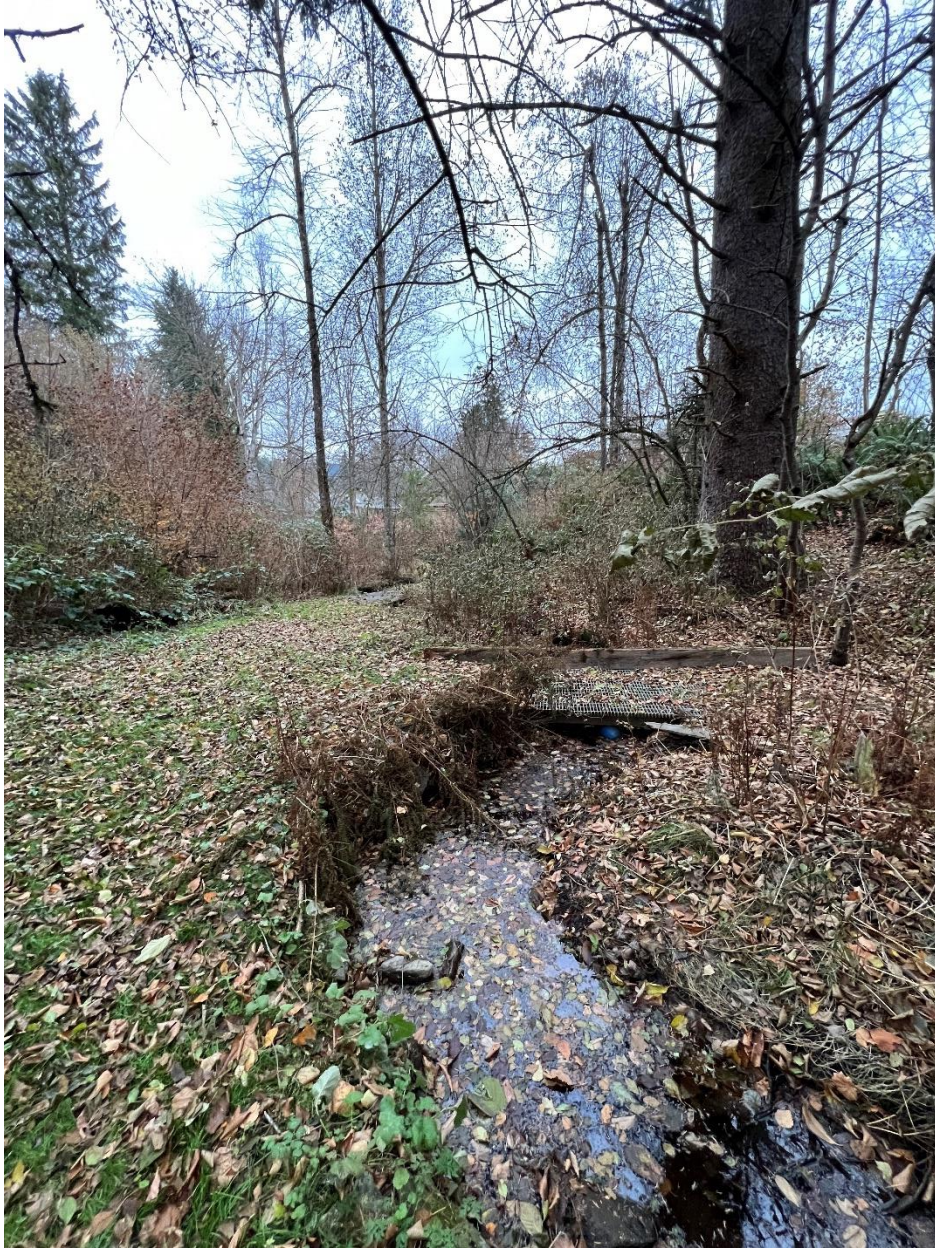
Photograph 3. View, facing north, of the stream showing channelization and meandering with semi-maintained yard and walkway crossing.

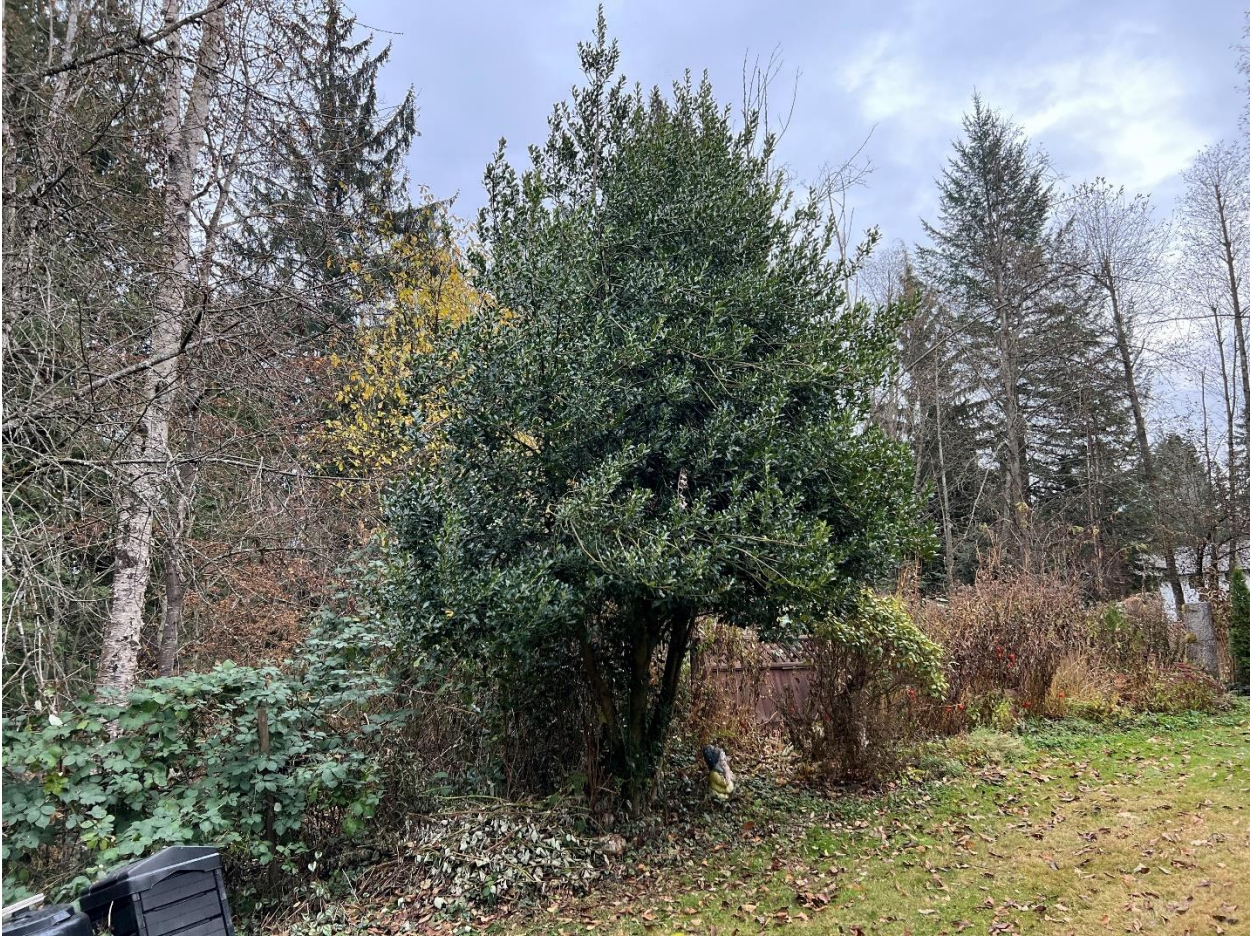
Photograph 4. View looking east of the northeastern corner of the existing lot where the SPEA enters the subject property. The holly tree (center of frame) is located immediately outside of the SPEA boundary, with the Himalayan blackberry and composting bins (left of frame) located inside the SPEA. Riparian trees within the SPEA were located in the neighbouring property and are not to be impacted by development.

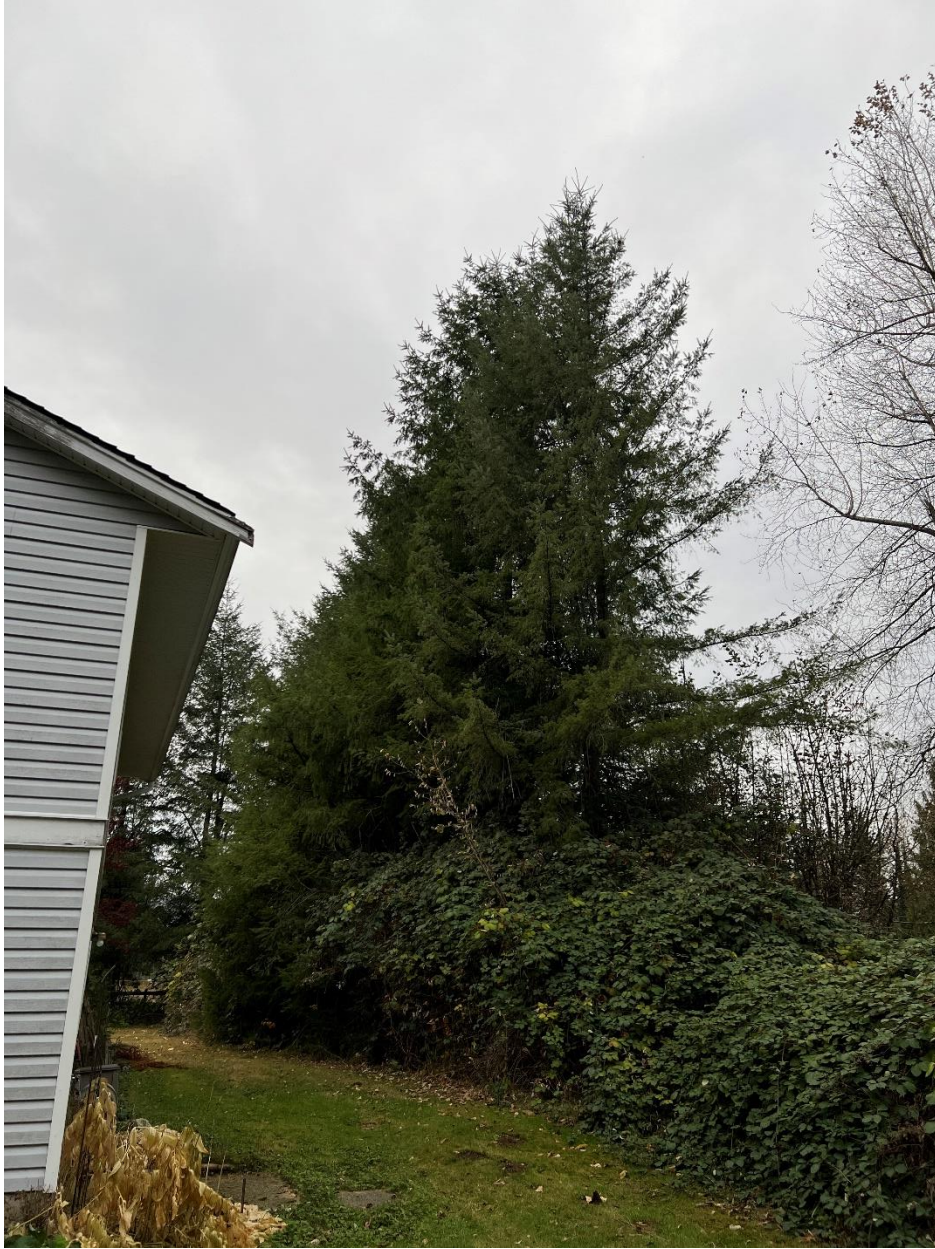
Photograph 5. View of the lawn, hedgerow of Douglas firs and Himalayan blackberry along the northern perimeter of the subject property which is contained within the designated PNA to the west of the SPEA.

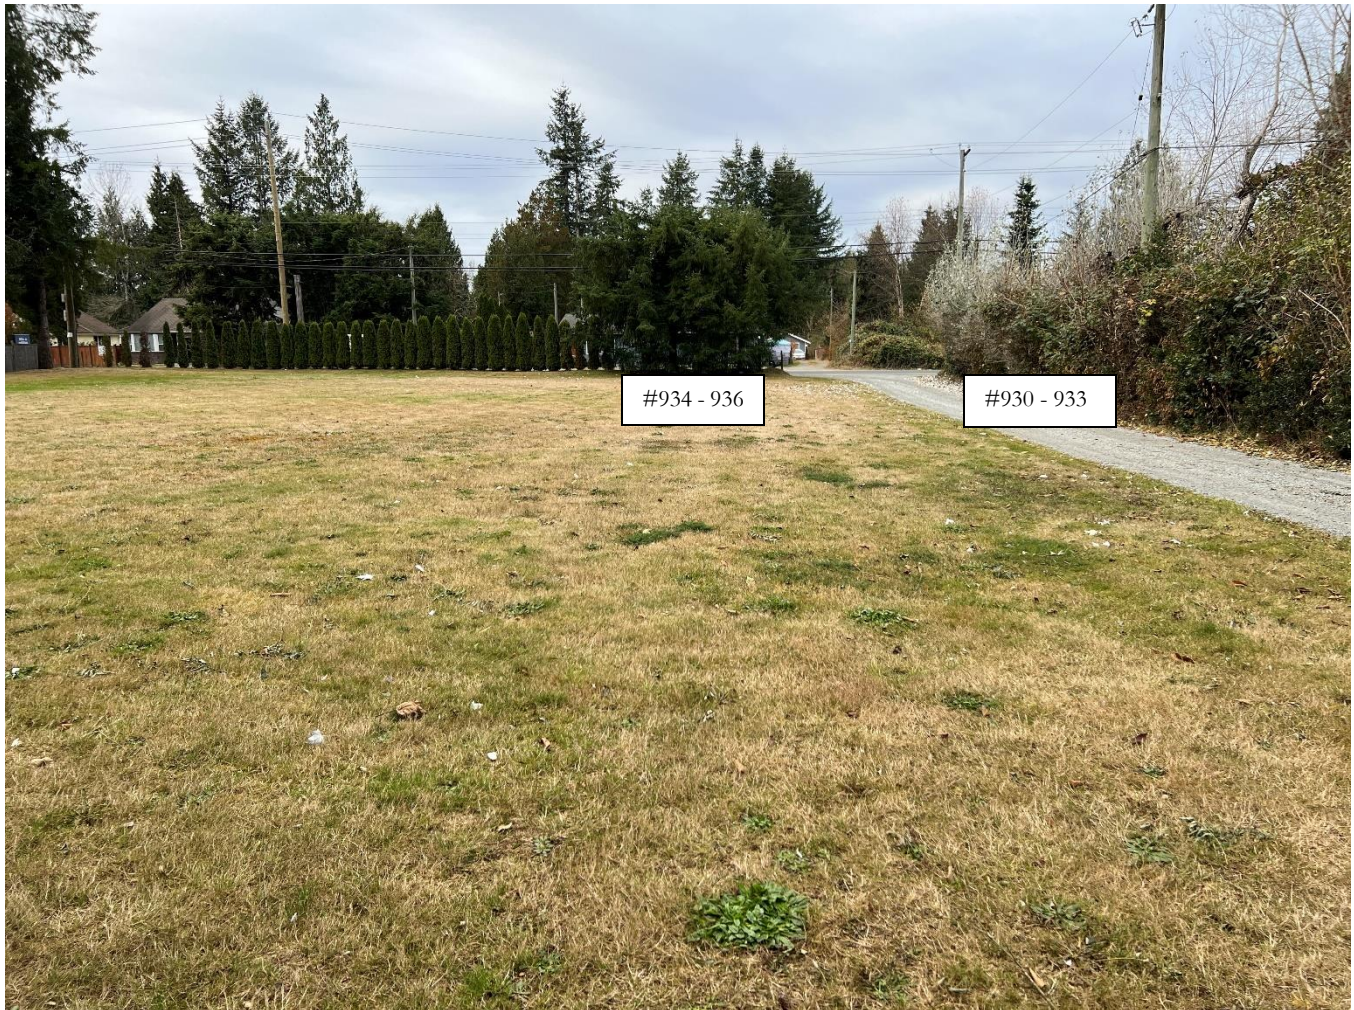
Photograph 1. View of the front yard and driveway of the subject property, facing Cedar Street to the west. Small hedge trees, shrubs, and a large open lawn occupied this portion of the lot. A row of white poplars (trees #930 – 933) and Himalayan blackberry grew to the north of the driveway.

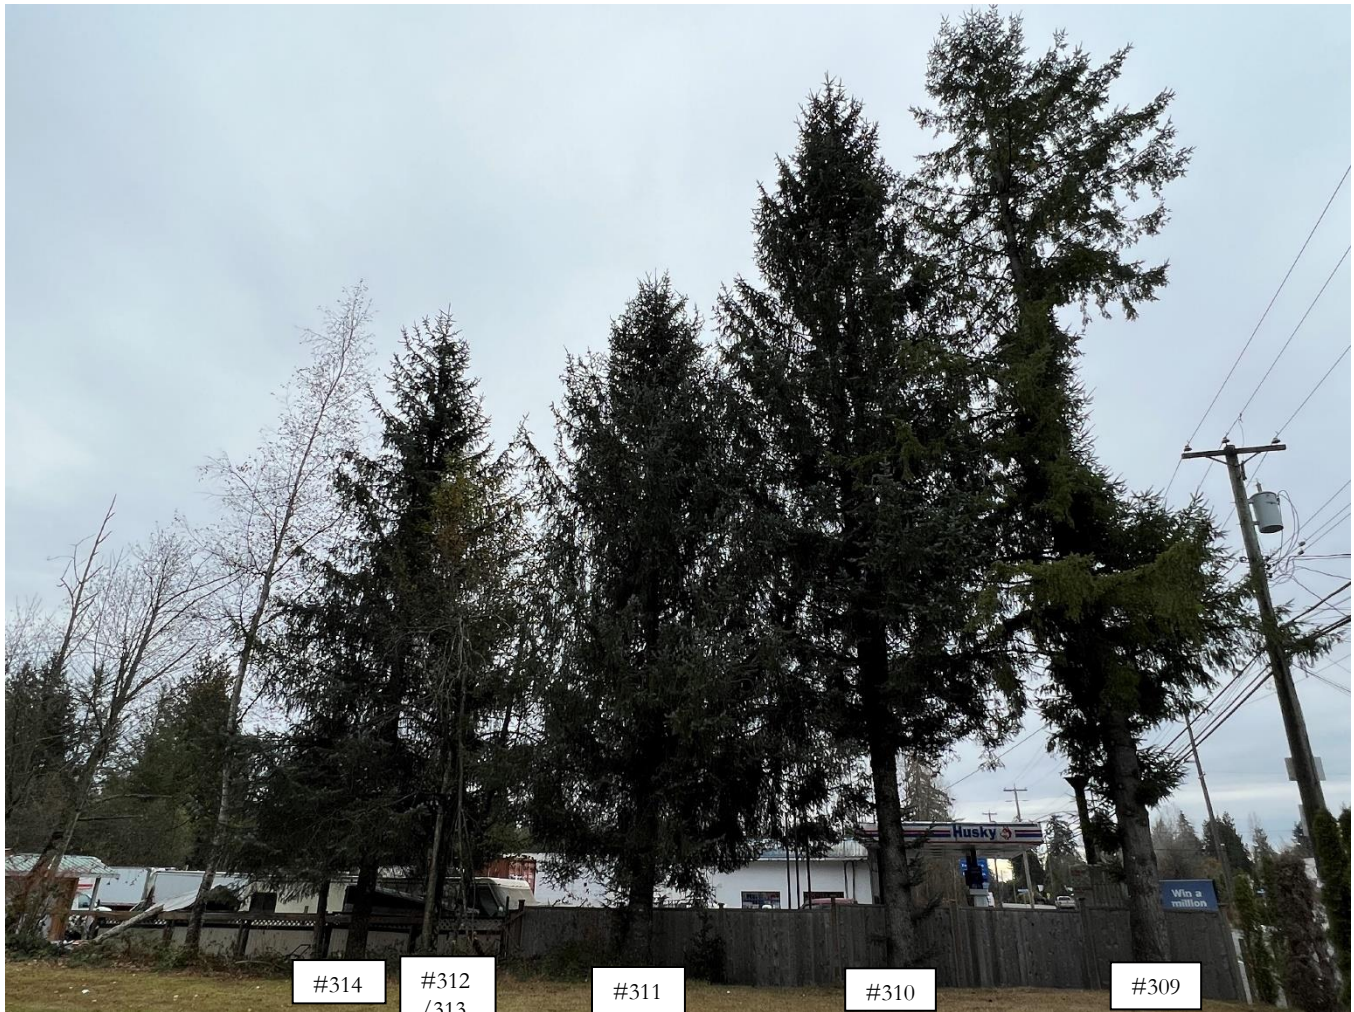
Photograph 3. View of the southwest corner of front yard with mature conifers along southern perimeter.

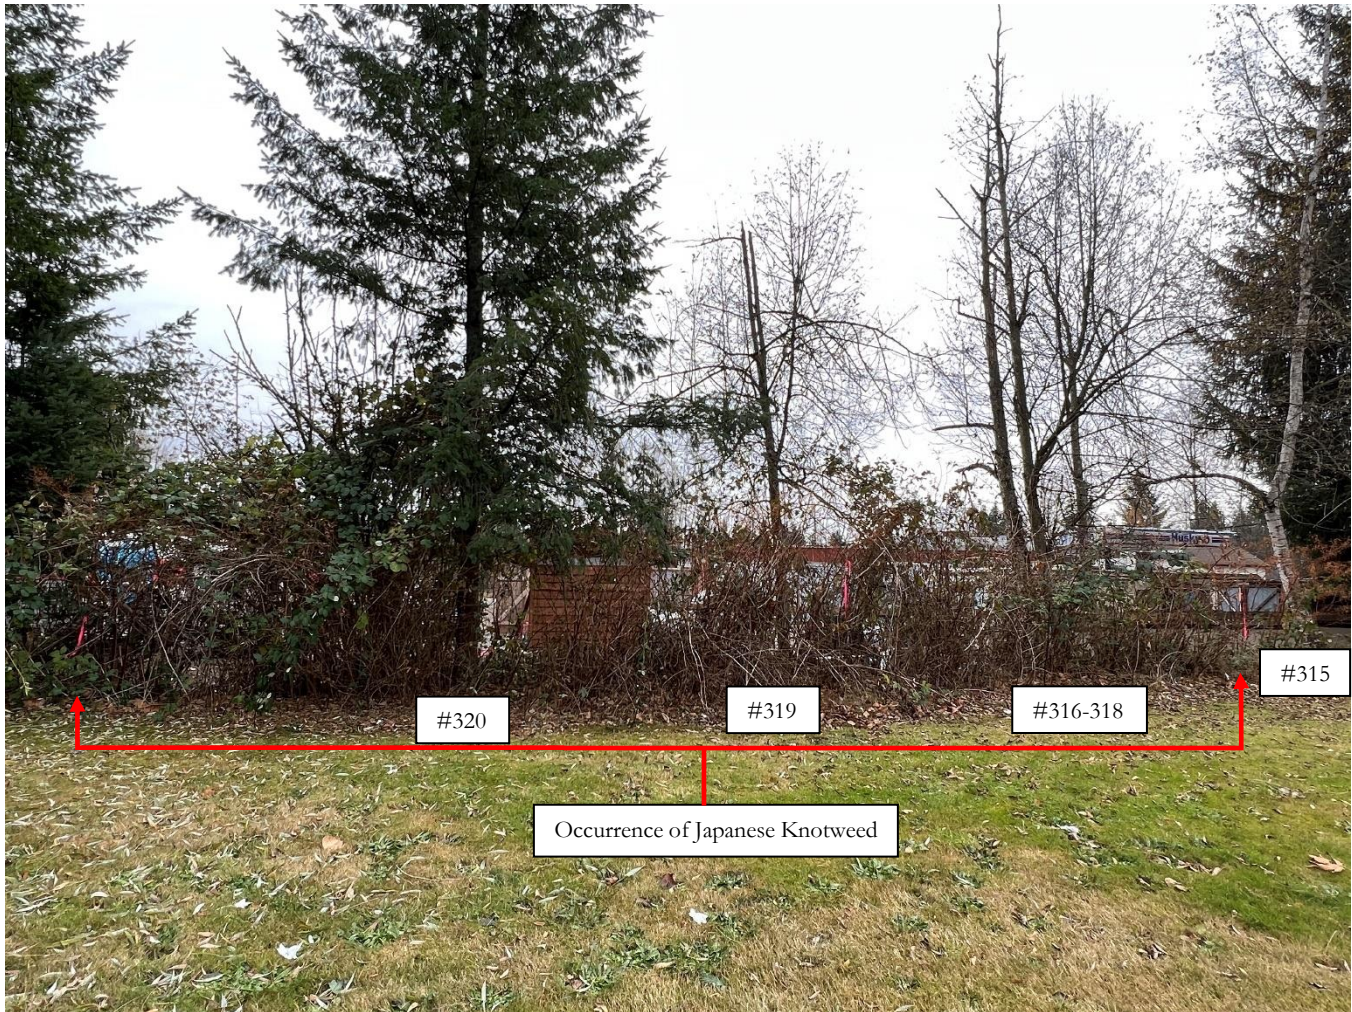
Photograph 4. View of Japanese knotweed (flagged with 3 pink ribbons) along the southern perimeter interspersed with Himalayan blackberry and several deciduous trees. Trees #317, 318, 319 were in a state of decay and/or poor condition.

- 5) Invasive vegetation species noted above should be removed from the property and/or chemically treated during development works. The removal or treatment of knotweed species in particular, to prevent their spread, is a legislated requirement for the development of the property.

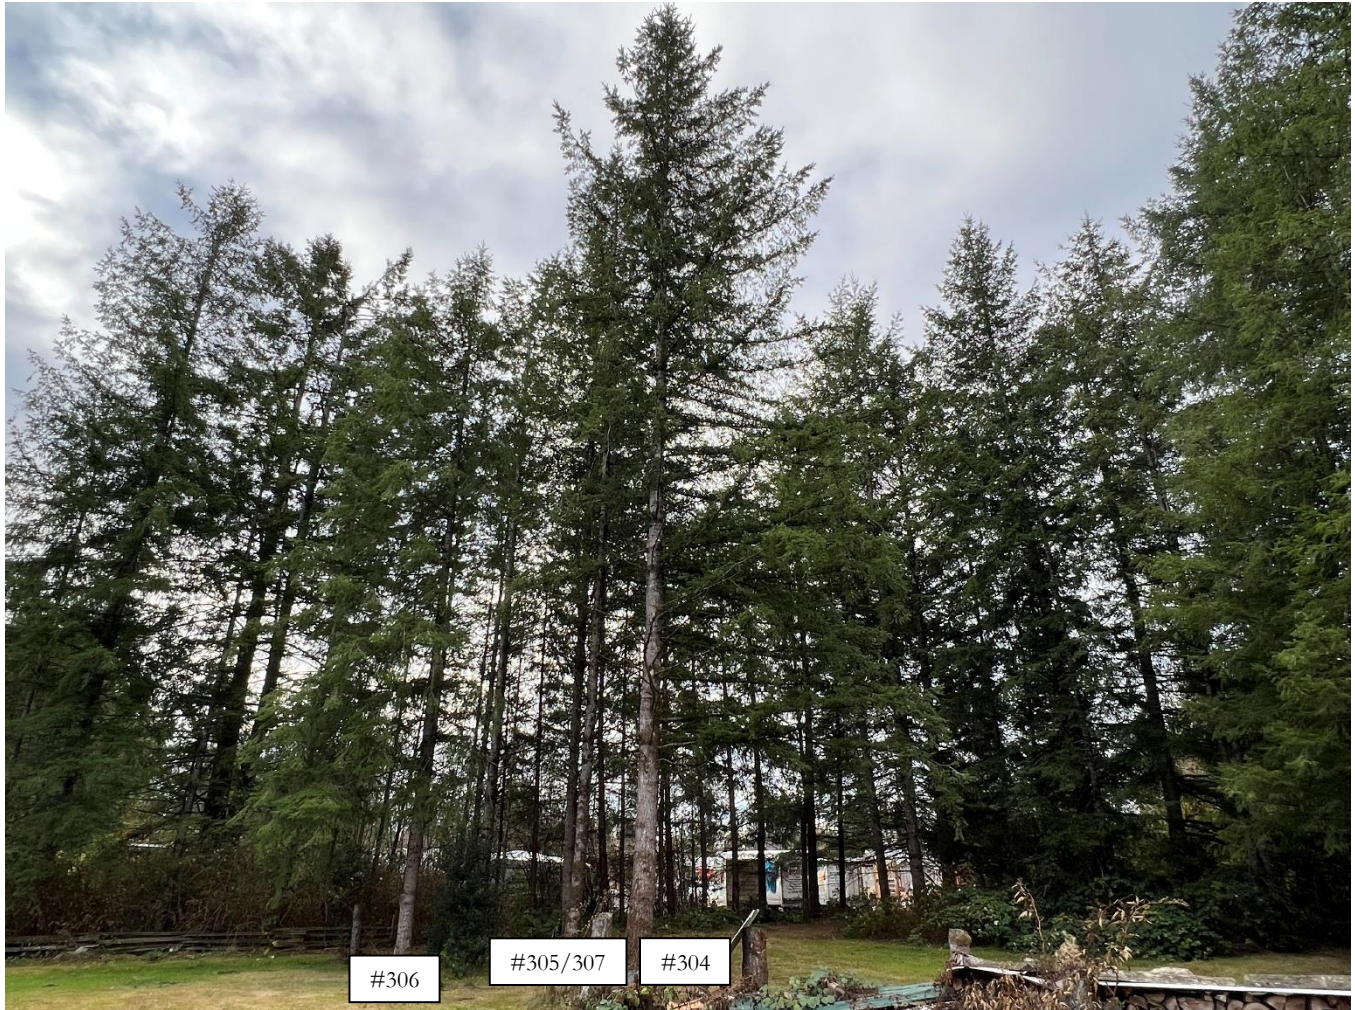
Photograph 5. View facing south of the Douglas firs located in the central portion of the lot adjacent a garden and firewood stacks.

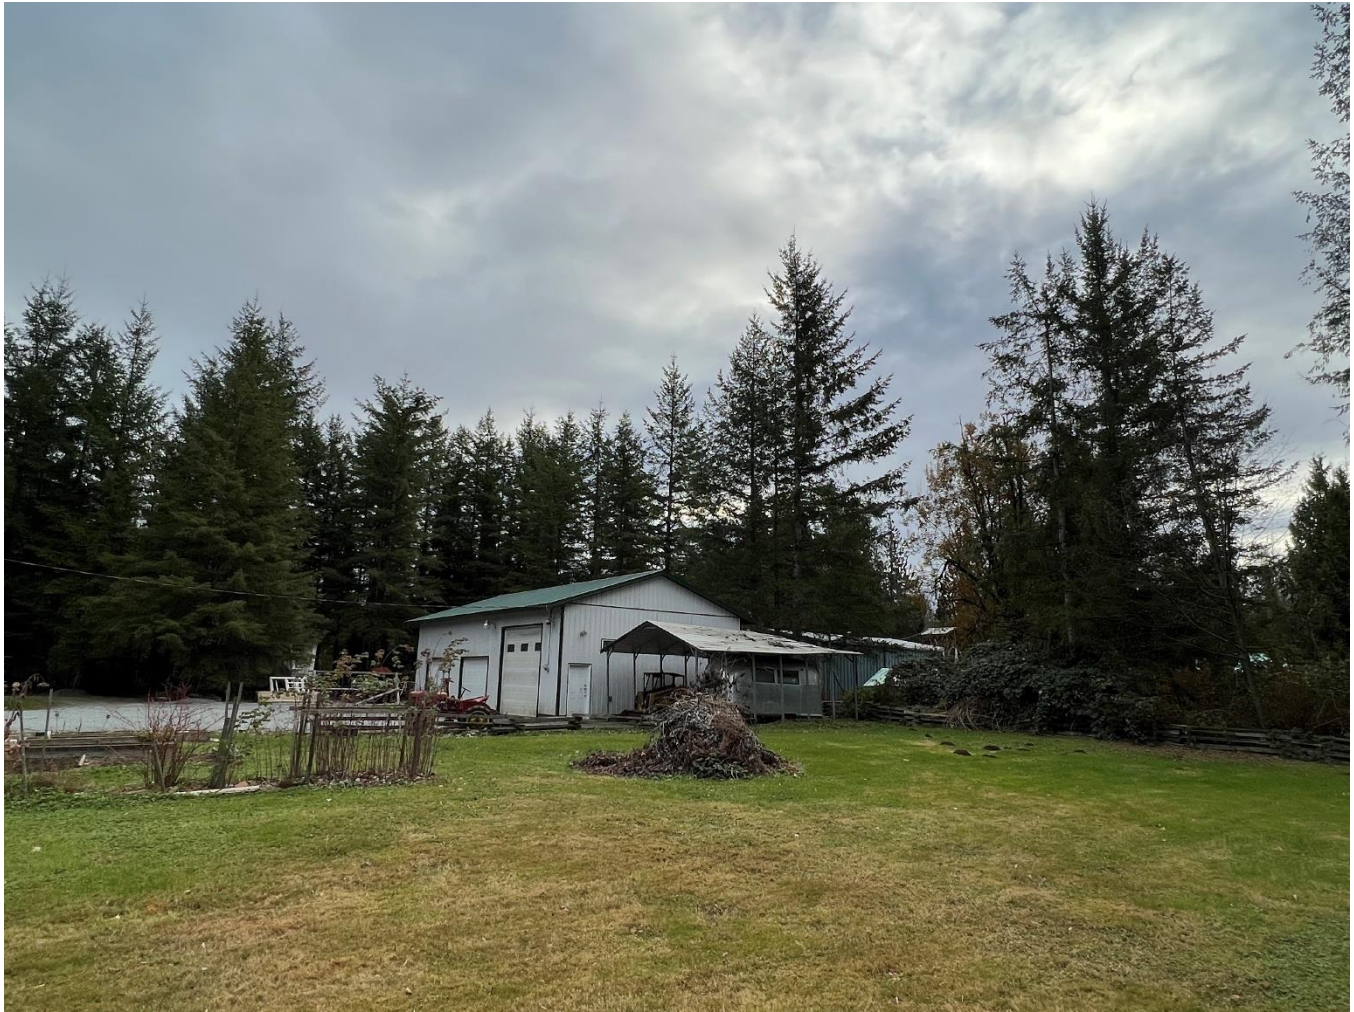
Photograph 6. View of the central and southeast portion of the lot consisting of maintained lawn, gardens, machinery shop, and a dense stand of conifers along the eastern perimeter. Dense thickets of native and invasive shrubs were located along the southern perimeter, providing small areas of moderate quality habitat.

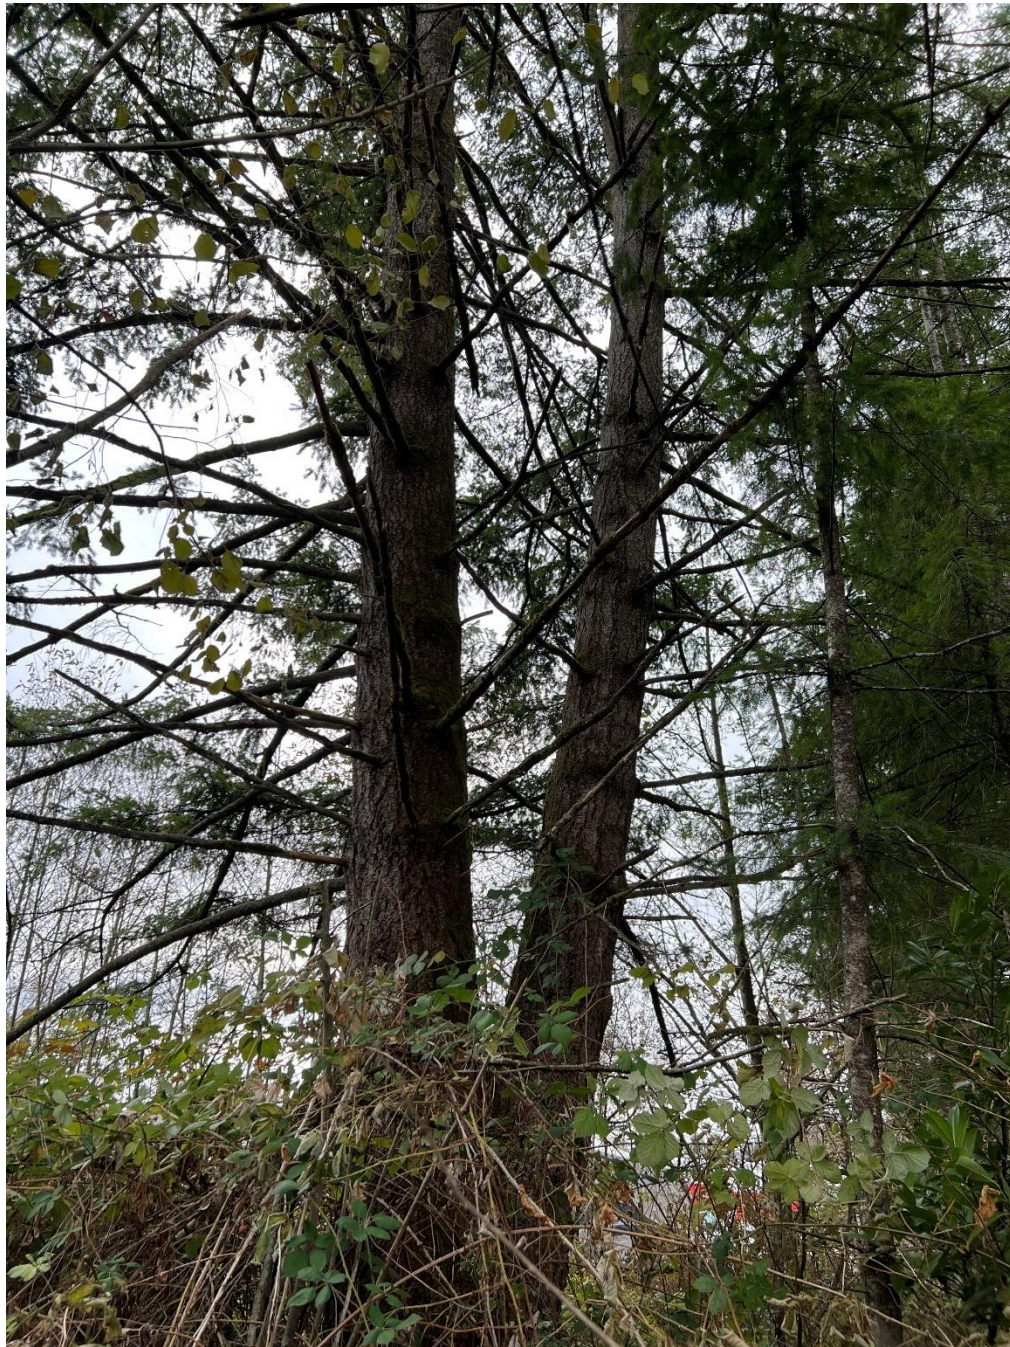
Photograph 7. Tree #336, located off site to the south, is recommended for retention. A large Douglas fir (110 cm DBH) with codominant stems, it was in good condition.

One Douglas fir, #336, was assessed off-site and to the south of the subject property, as it had a significant size (110 cm DBH). It is recommended for retention and for tree protection fencing installed at 6.6 m from the stem (Figure 4). Other off-site trees included on the survey drawing (OS1 through

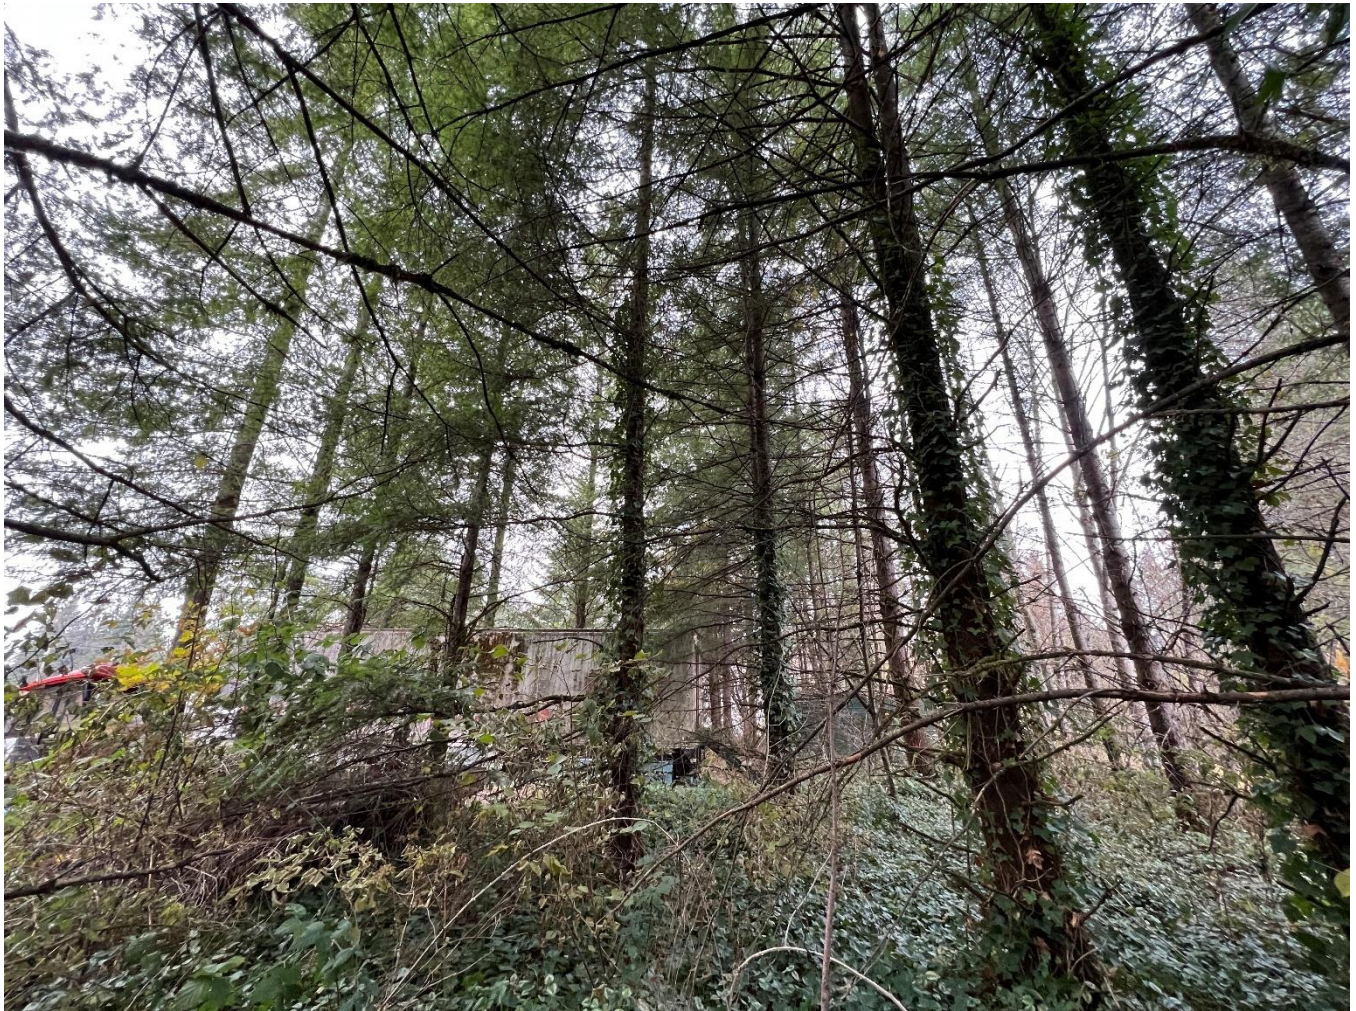
Photograph 8. View from within the eastern stand of conifers, facing north. English ivy and Himalayan blackberry were prevalent throughout the understory.

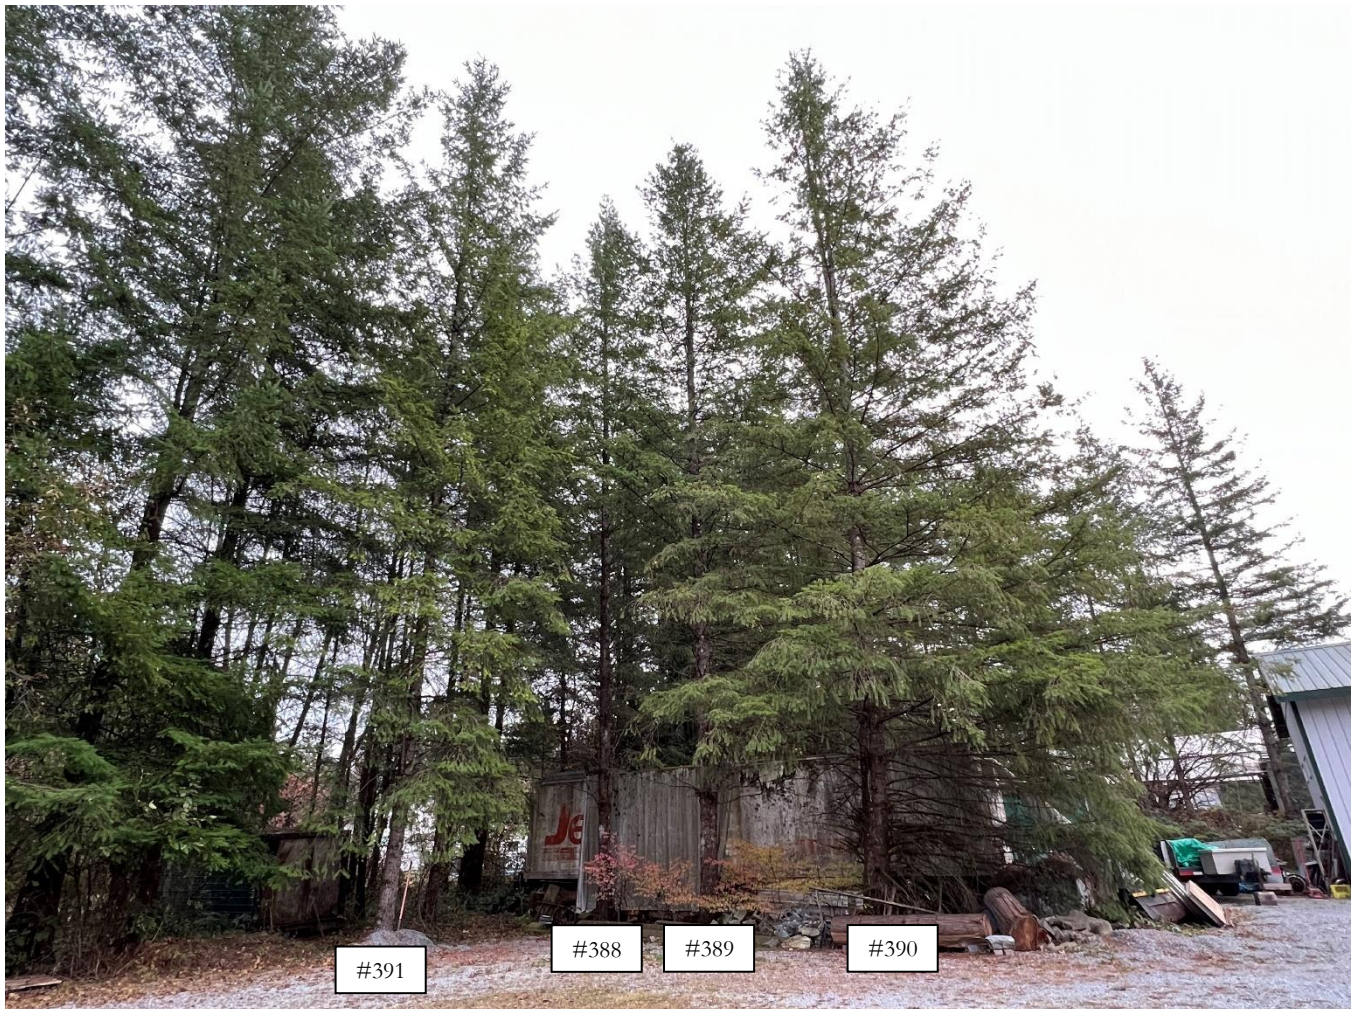
Photograph 9. View of the eastern stand of conifers facing southeast. Storage containers and equipment were located along the vegetated areas.

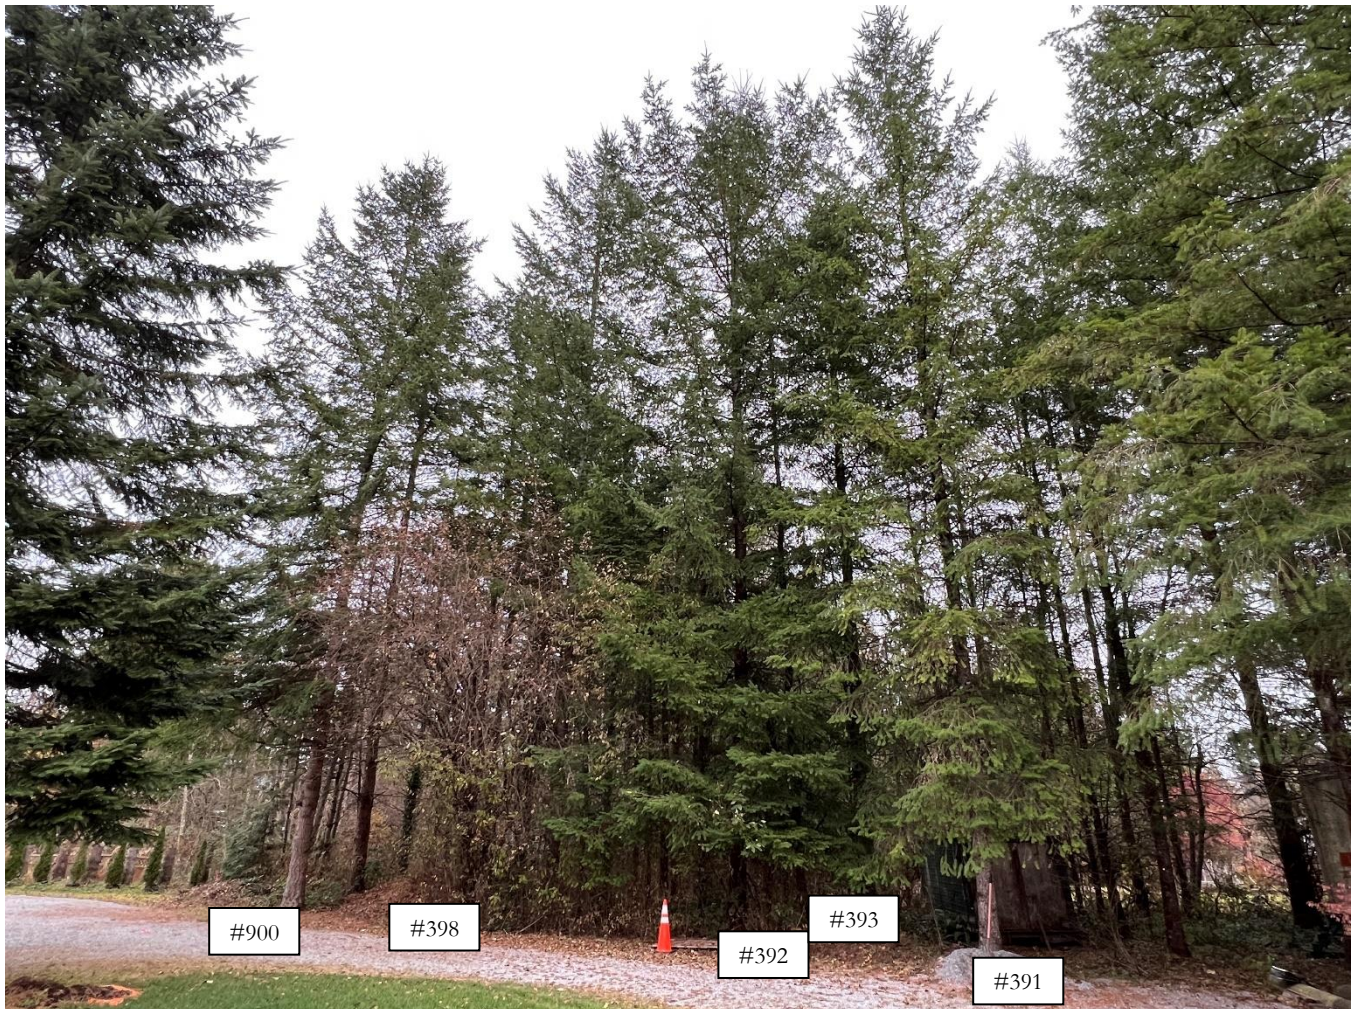
Photograph 10. View of the eastern stand of trees located alongside the gravel driveway. The northeast portion of this stand is located within the PNA and is to be protected from development impacts.

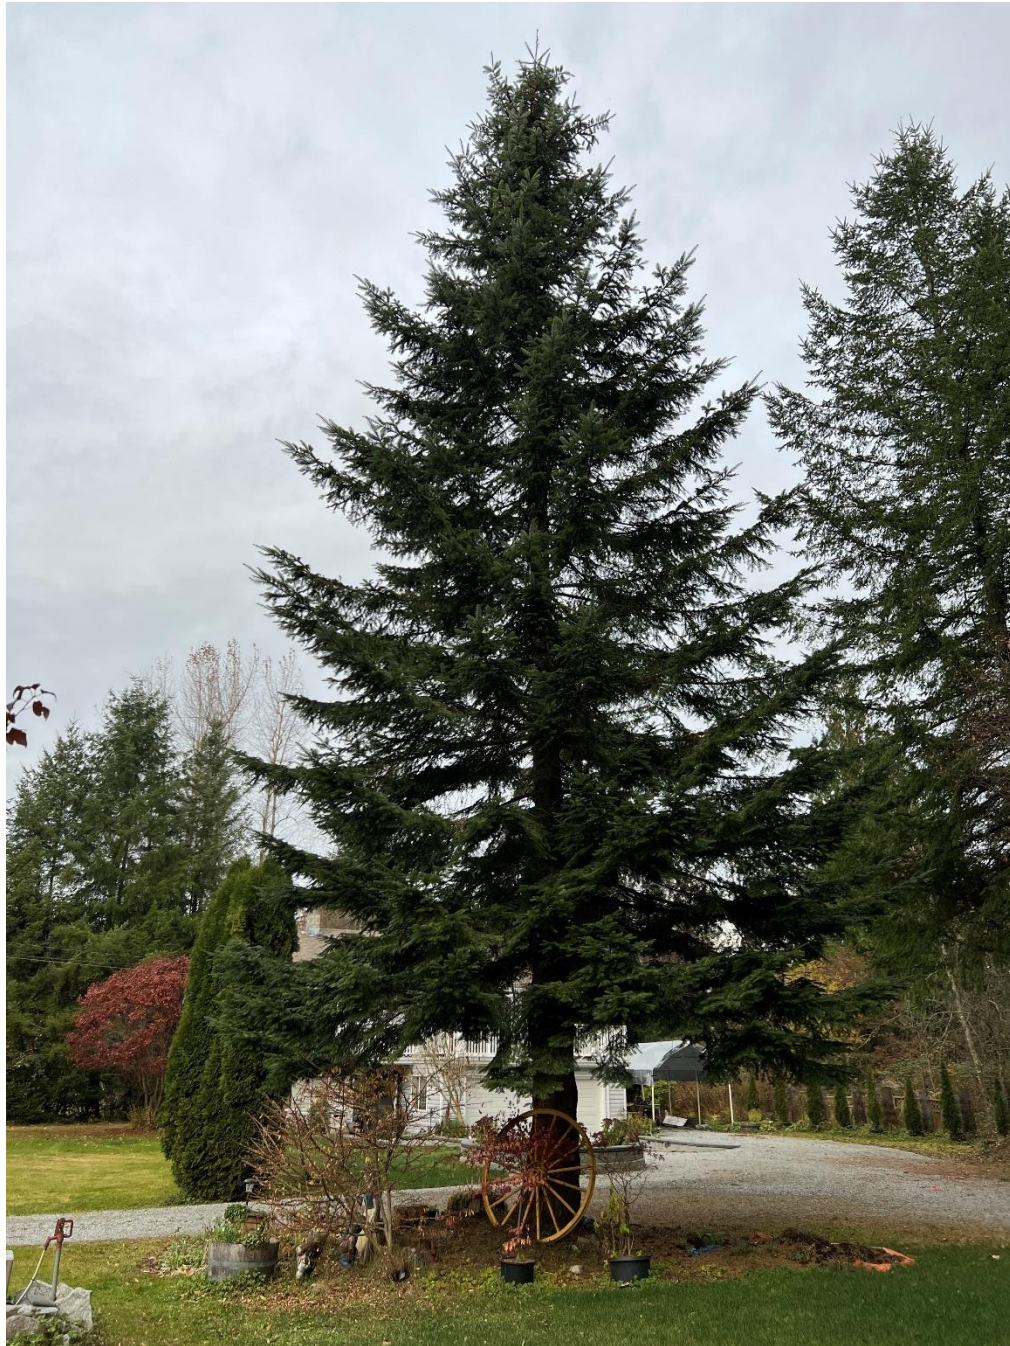
Photograph 11. Tree #265, a grand fir in good condition, located in the center of the driveway roundabout in front of the house.

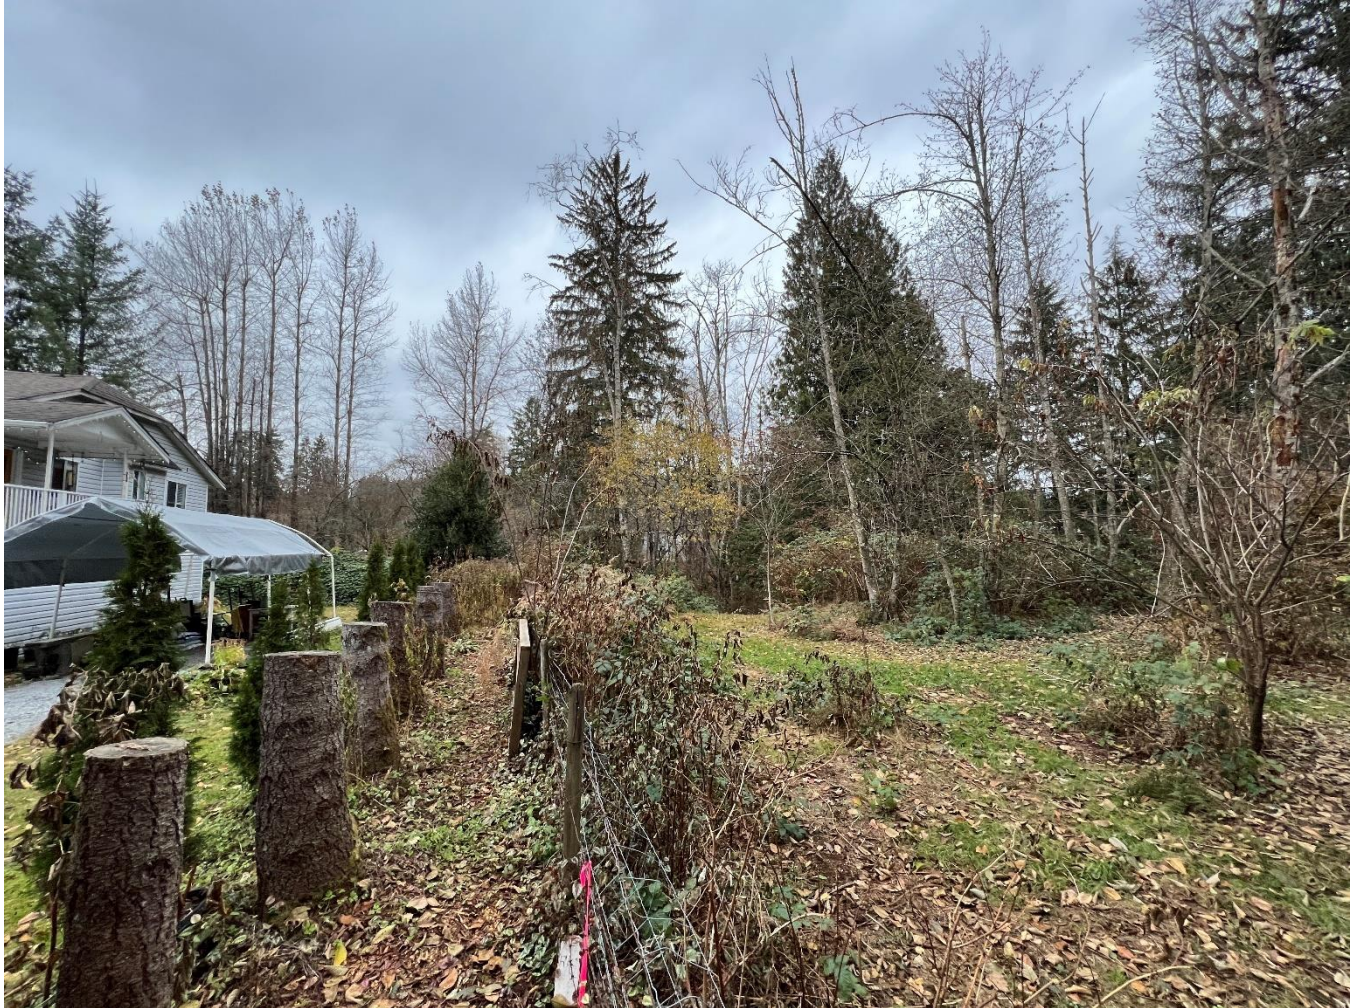
Photograph 12. View of the northeast corner of the subject property (house, carport, cedar hedges and row of cut stumps) and adjacent lot the east consisting of semi-maintained riparian vegetation around the watercourse.
