CITY OF MISSION DEVELOPMENT PERMIT DP23-035

Development Permit DP23-035

Riparian Areas Protection Regulation - Qualified Environmental Professional - Assessment Report

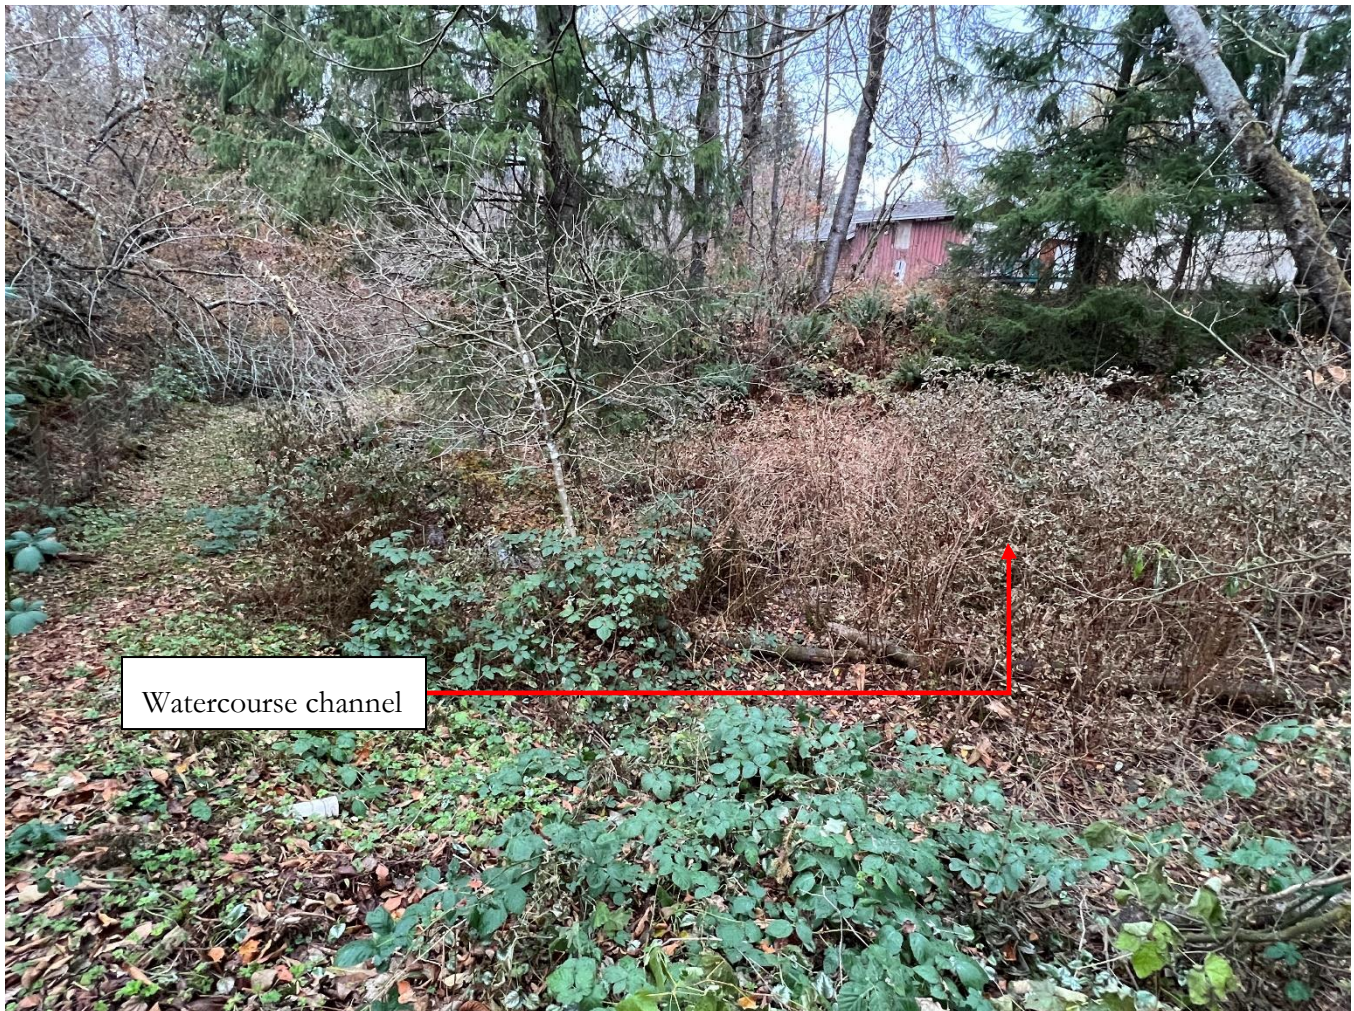
Photograph 13. View of the mixed native and invasive riparian vegetation on the adjacent property, located approximate 10 m from the subject property.

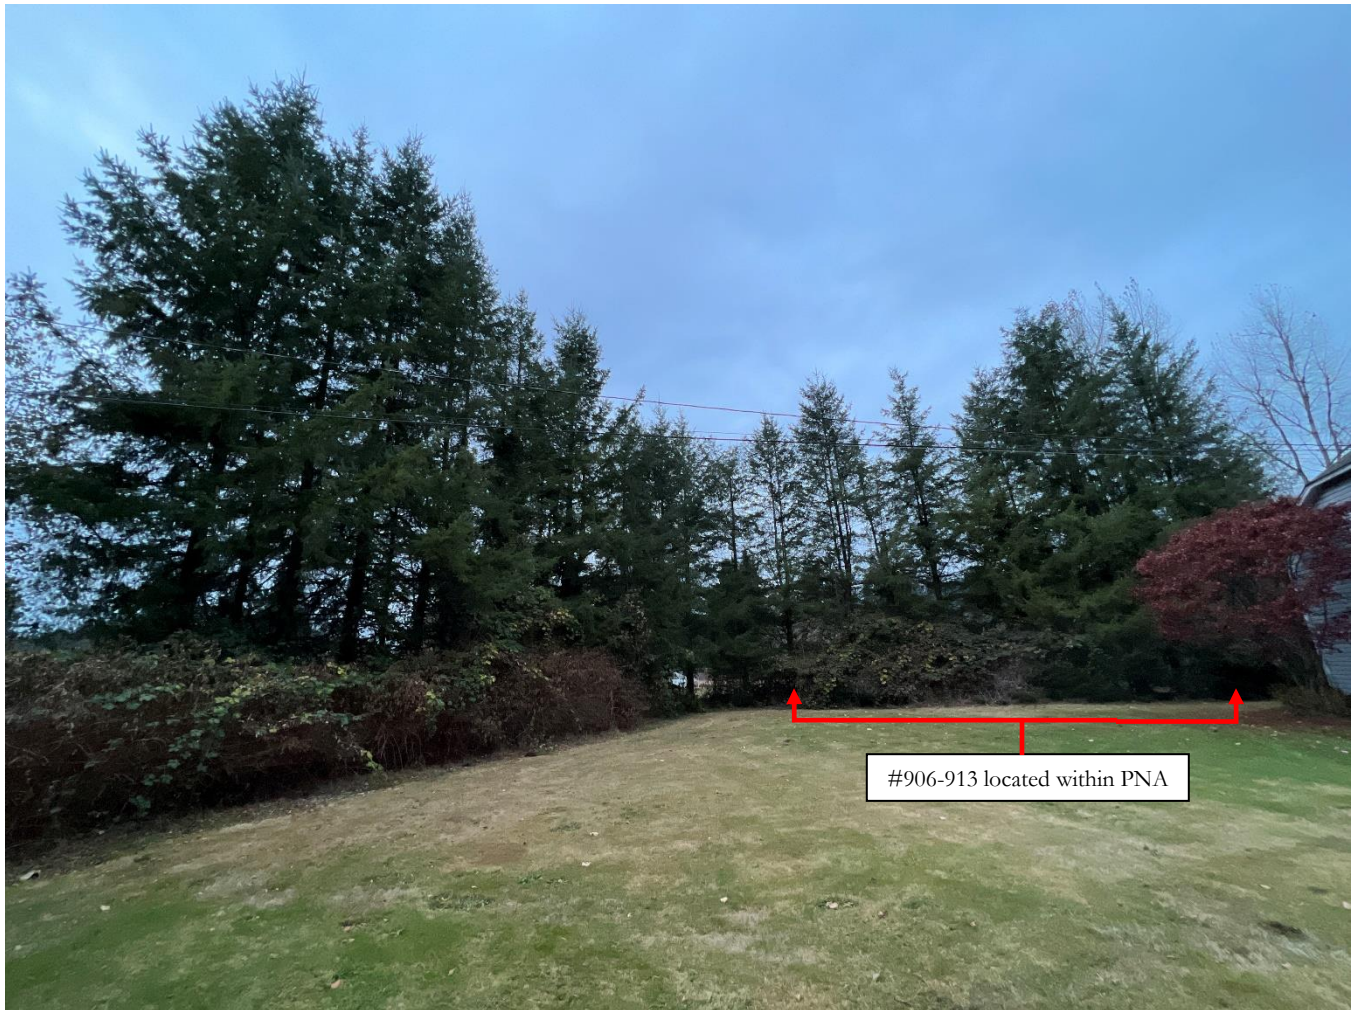
Photograph 14. View of the northern portion of the yard, west of the house. Hedgerows of Douglas fir (trees # 906 – 926) and Himalayan blackberry were located along the property line. Trees #906-913 were located within the PNA and are to be protected from development impacts.
