REVISED ARBORIST REPORT For 12631 Bell Street Mission, BC

Florwest Developments

February 14, 2023

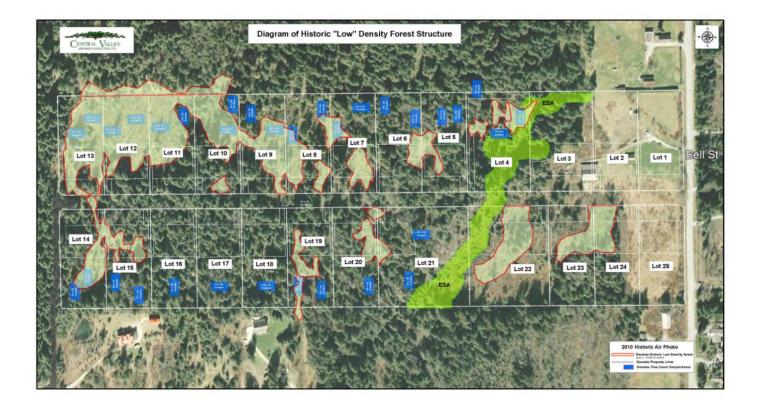
Diagram of Low Density Areas and the location of the sample plots. Note: Spread sheet (Chart A) can be Found on Page 12 of this report. The inserted diagram below can be found on Page 20.

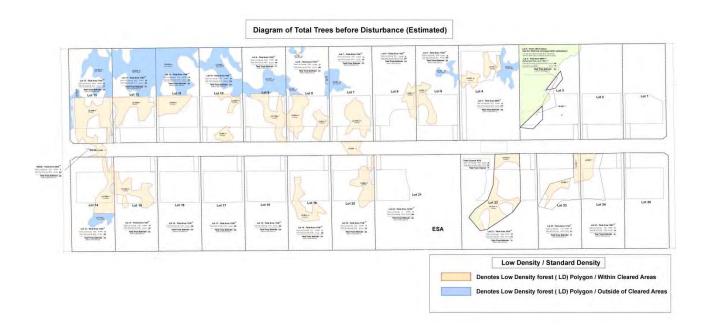
Inserted below is a diagram of the Low Density Area Polygons; Blue represents the Low Density areas in the remaining forest and Orange represents the Low Density Areas within the Cleared areas. This plan can be found on Page 22.

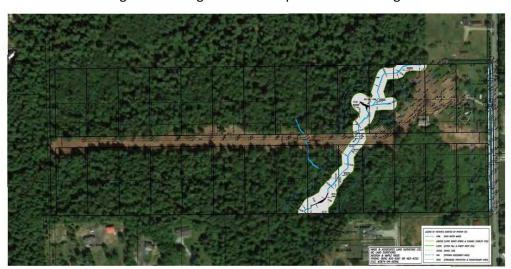
We did not include the space that was cleared for the roadway (9500 m²), as this will become a municipal street servicing all the homes, and is a necessary function of the new neighbourhood. Also, we understand that there was a Skidder road for logging that dissected the property. *See Below

Diagram showing Skidder road prior to lot clearing.
